Formerly Utilized MED/AEC Sites Remedial Action Program

**Removal of a Contaminated Industrial Waste Line,
Los Alamos, New Mexico**

Final Report

Los Alamos Scientific Laboratory

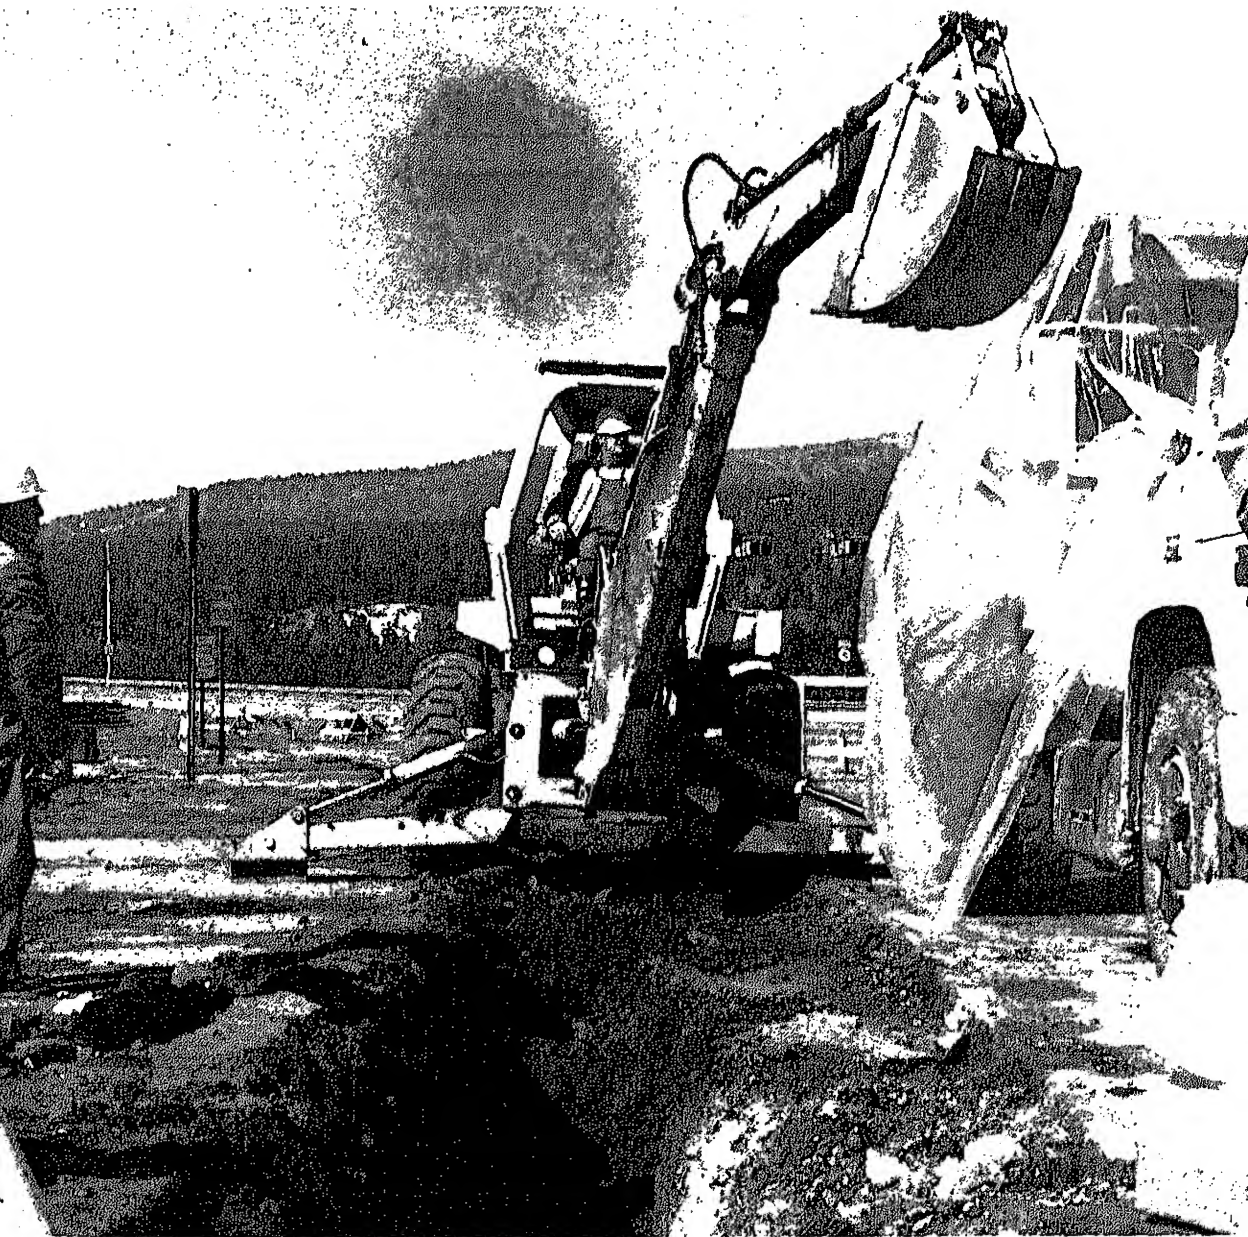
*Fig. 5.
Backhoe used to excavate a trench down to buried IWL.*

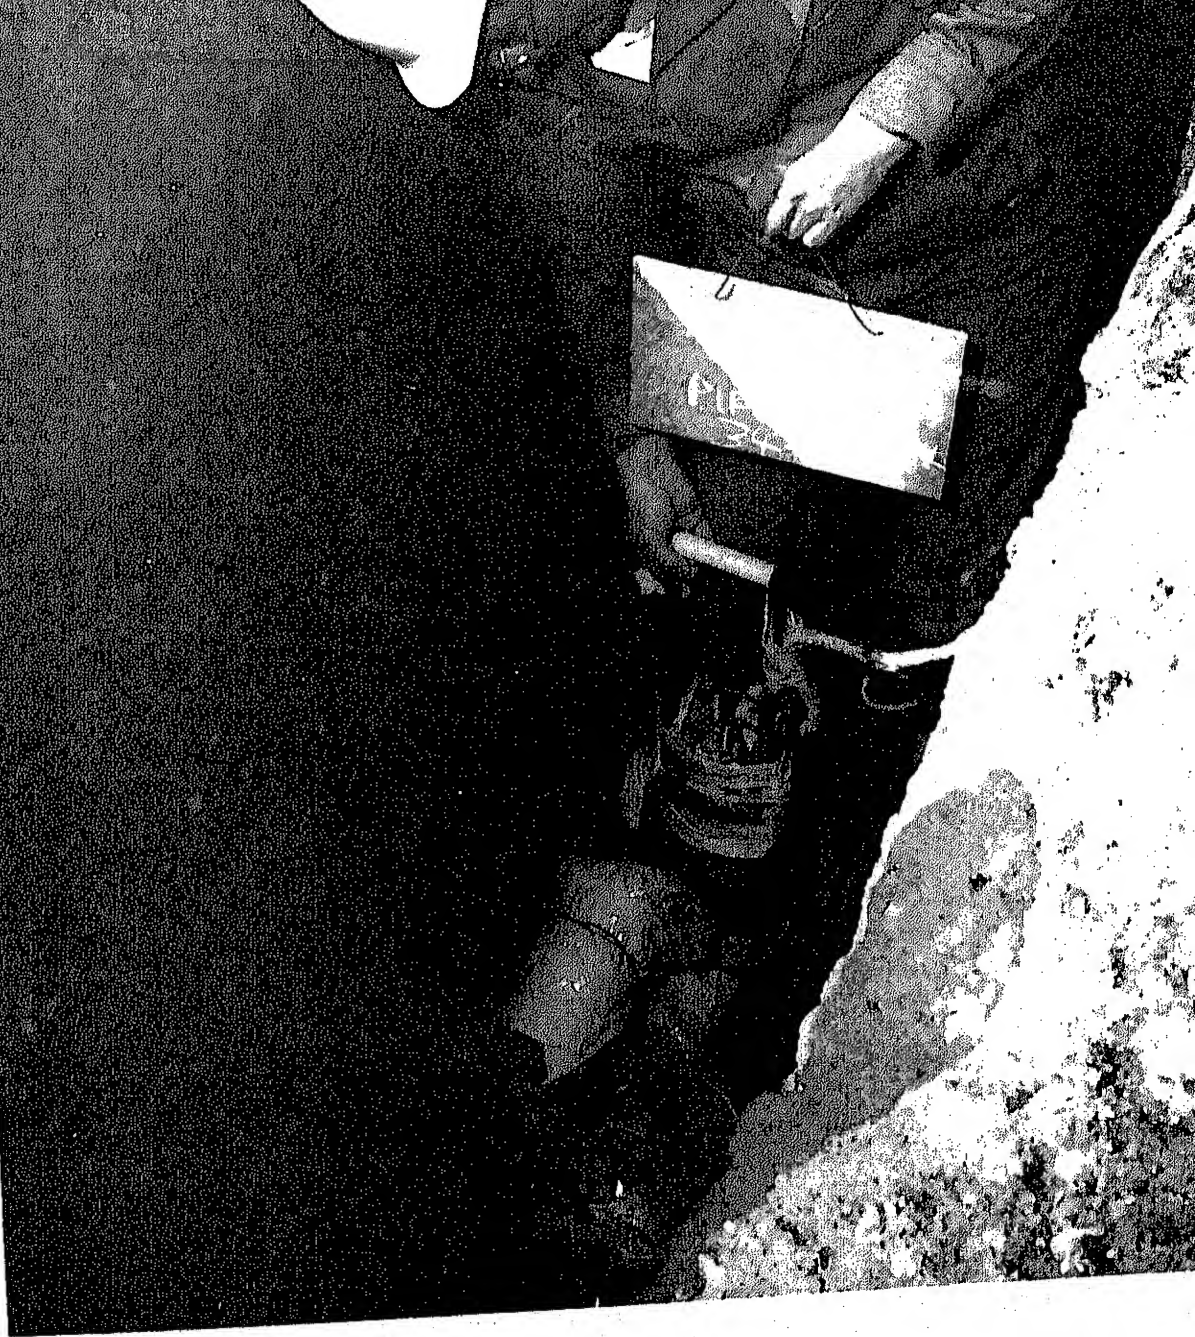
*Fig. 10.
Sealed IWL is monitored with a phoswich to determine if any activity is on the pipe's exterior.*

Any soil wetted with liquid from the pipe was sent in sealed plastic bags to the radioactive waste disposal site. Monitoring of the sealed pipe with a phoswich determined if any activity were on the pipe's exterior (Fig. 10). A soil sample was collected under the cut (Fig. 11). Each joint underwent visual inspection and monitoring to determine if any leaks had occurred in the past. The pipe section was then removed from the trench (Fig. 12) and placed into dump trucks for shipment to the disposal site. The dump truck beds were lined with plastic (Fig. 13) and a custom-made tarpaulin covered the load while in transit to the waste disposal area (Fig. 14). The trucks were monitored before returning for their next load to ensure against carrying contaminated material from the disposal area.

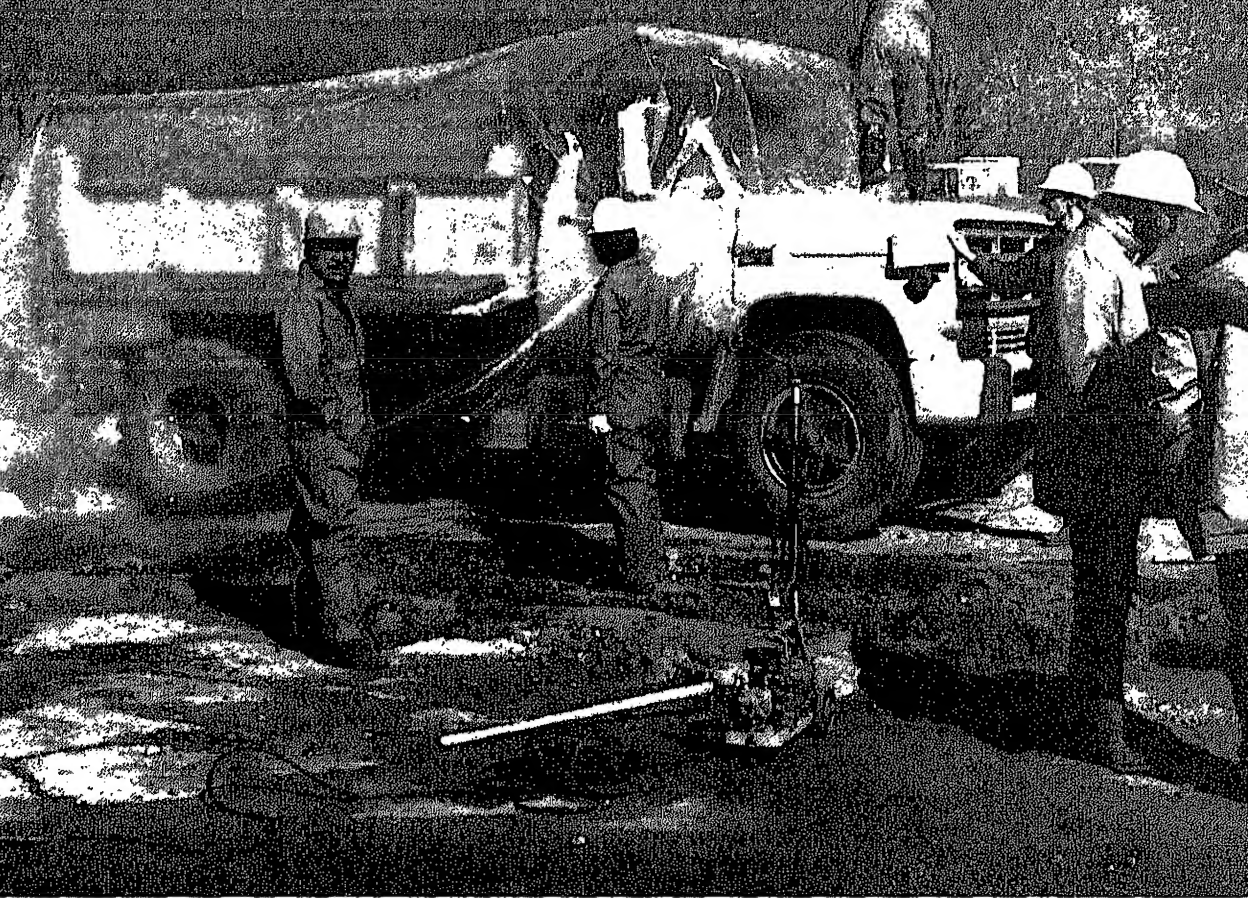
*Fig. 13.
Dump truck beds are lined with plastic to prevent soil spillage.*

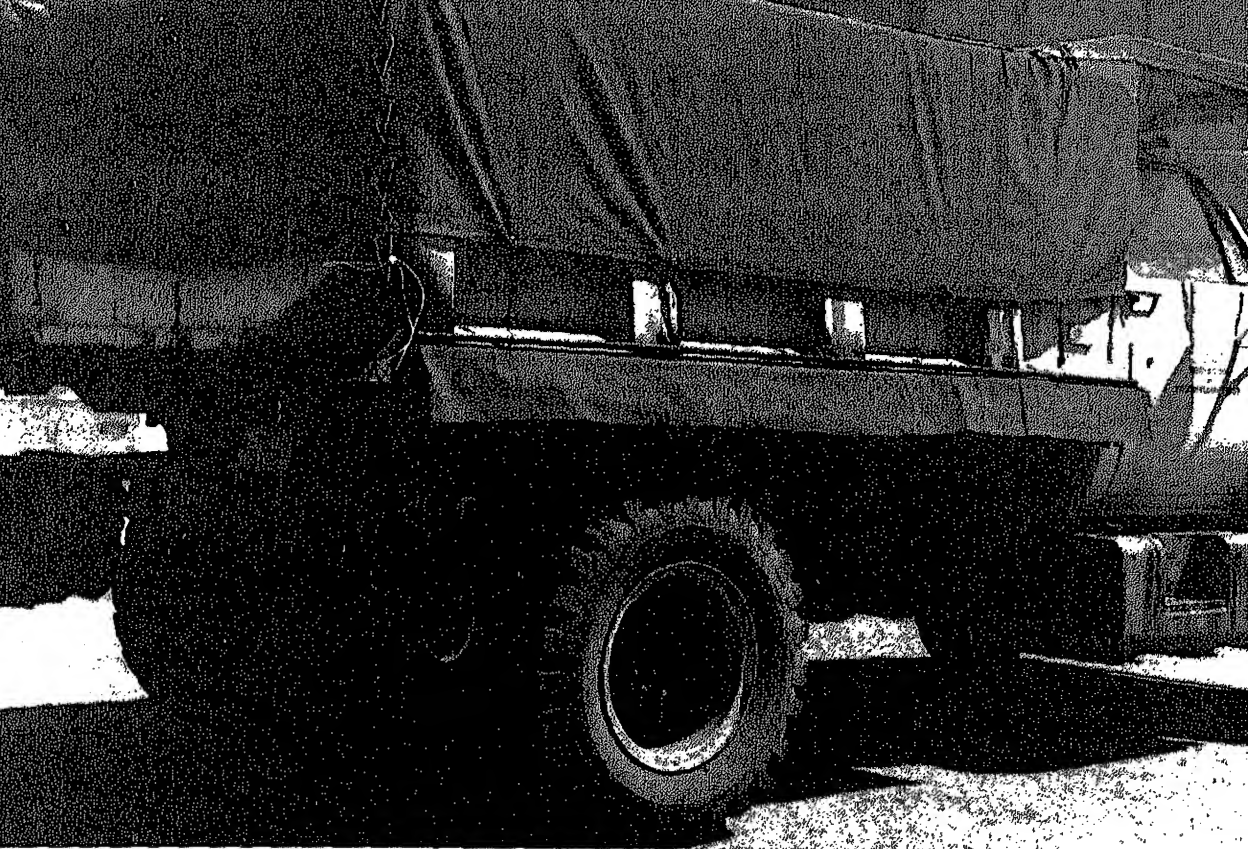
Fig. 14.
A tarpaulin covers a load of contaminated soil.

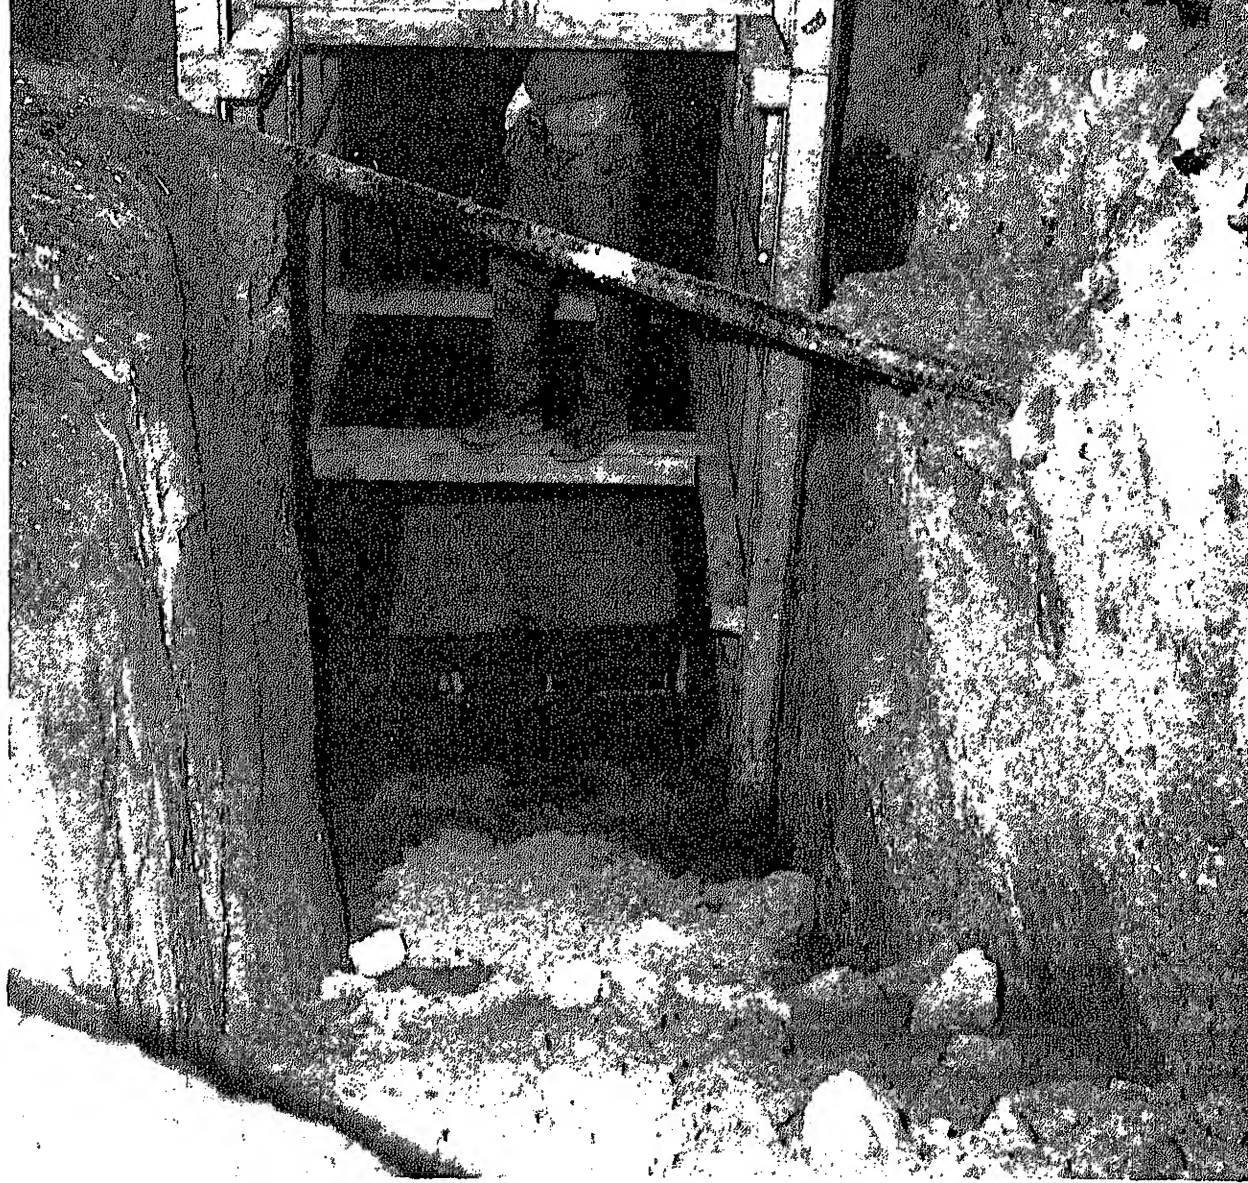
Fig. 16.
Shoring system used throughout the project.

a. Excavation Collapse. Since excavations were entirely in previously excavated soil with indeterminate grades of backfill, shoring in accordance with the Occupational Health and Safety Administration regulations⁶ was required during the entire project. The Zia Company (the LASL support contractor) devised a shoring system used throughout the project (Fig. 16). The shoring proved itself on May 11, 1977, when a section of the soil, weighing about 1000 kg, collapsed and

was restrained by the shoring. Three workers were in the trench at that time, but none were hurt. In several places, it was advantageous to remove about a meter of soil prior to trenching to eliminate or reduce the need for shoring. A backhoe removed pipe directly along the deepest section of the trench, eliminating the need for personnel entry into the trench.

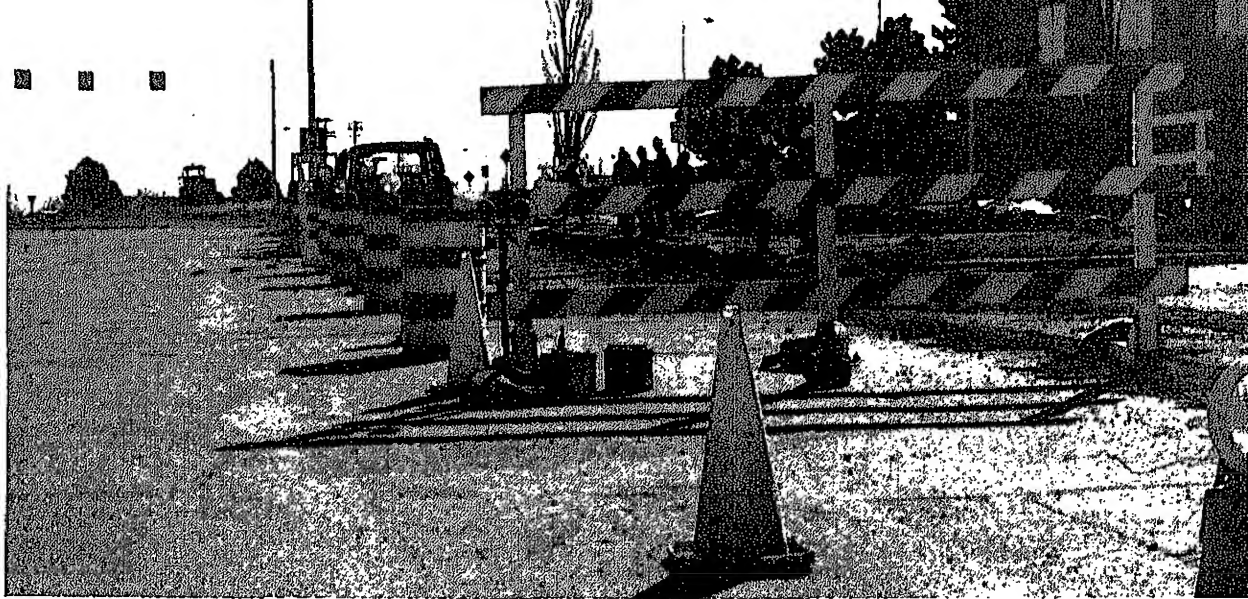
Fig. 17.

Traffic control barricades assist trucks in entering and exiting the construction area.

b. Traffic Control. Traffic control plans developed and implemented for several phases of the project included barricades, signs, and flagmen to assist trucks in entering and exiting the construction area (Fig. 17). Two minor accidents occurred. The first involved an intoxicated driver driving an auto into one of the barricades. The second happened inside the construction zone and occurred when an unattended private vehicle rolled into a parked government vehicle. There were no injuries in either accident.

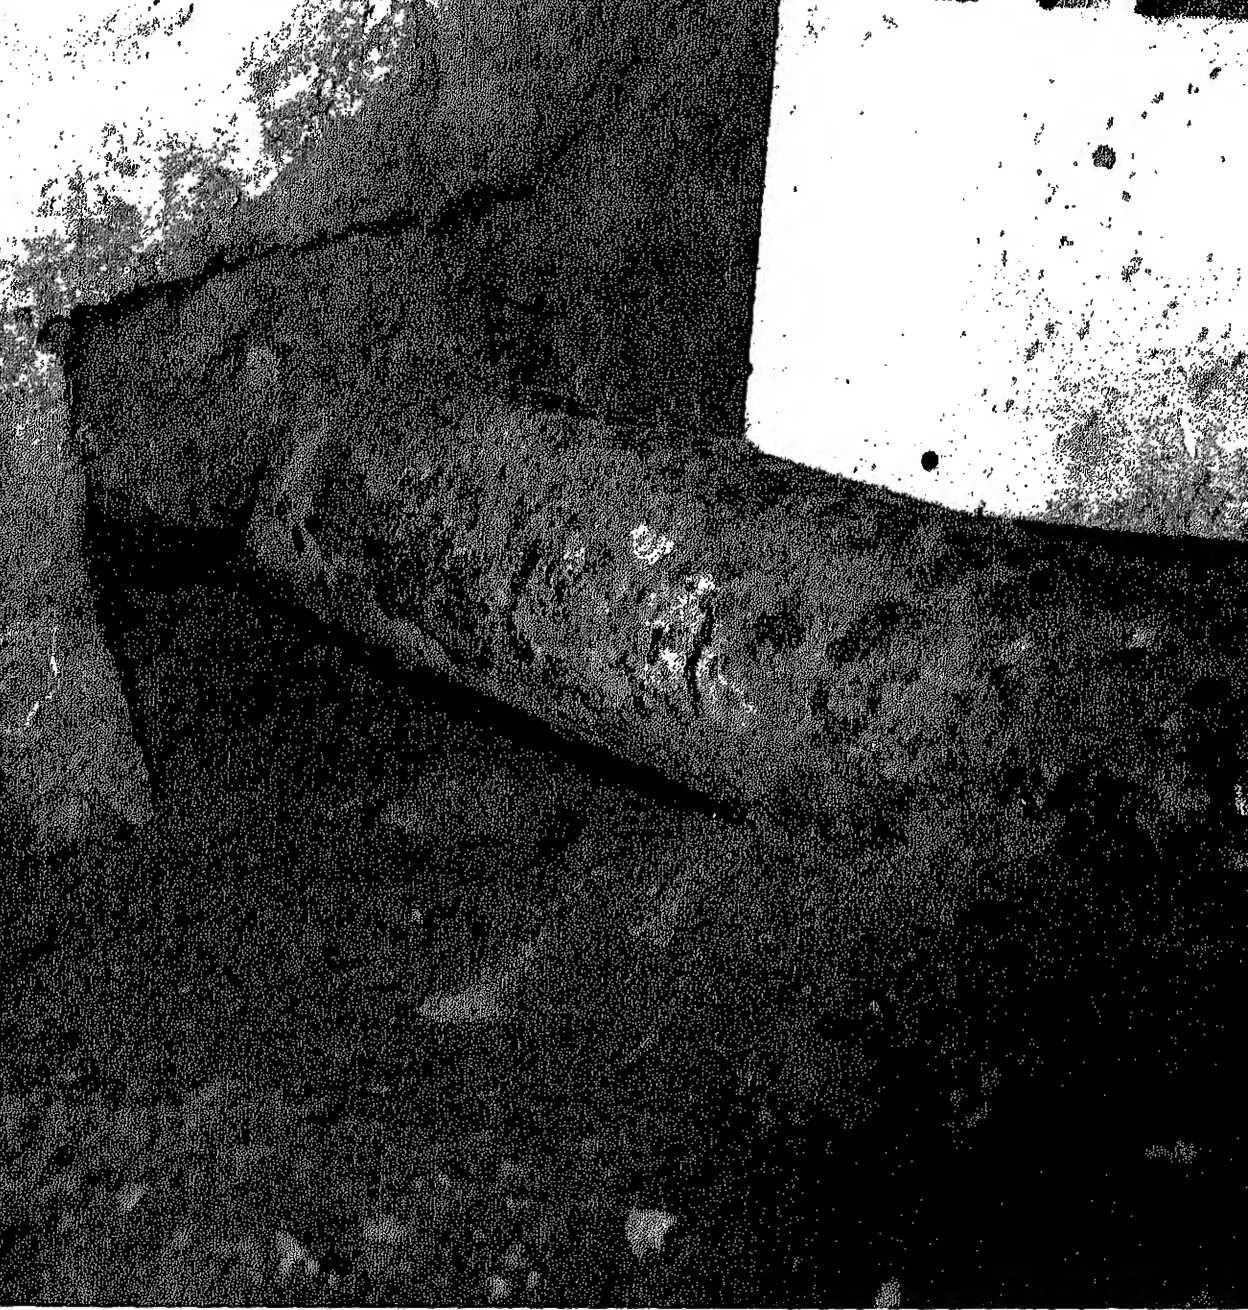
Fig. 22.
Inadequately sealed outlet port in manhole ULR-35.

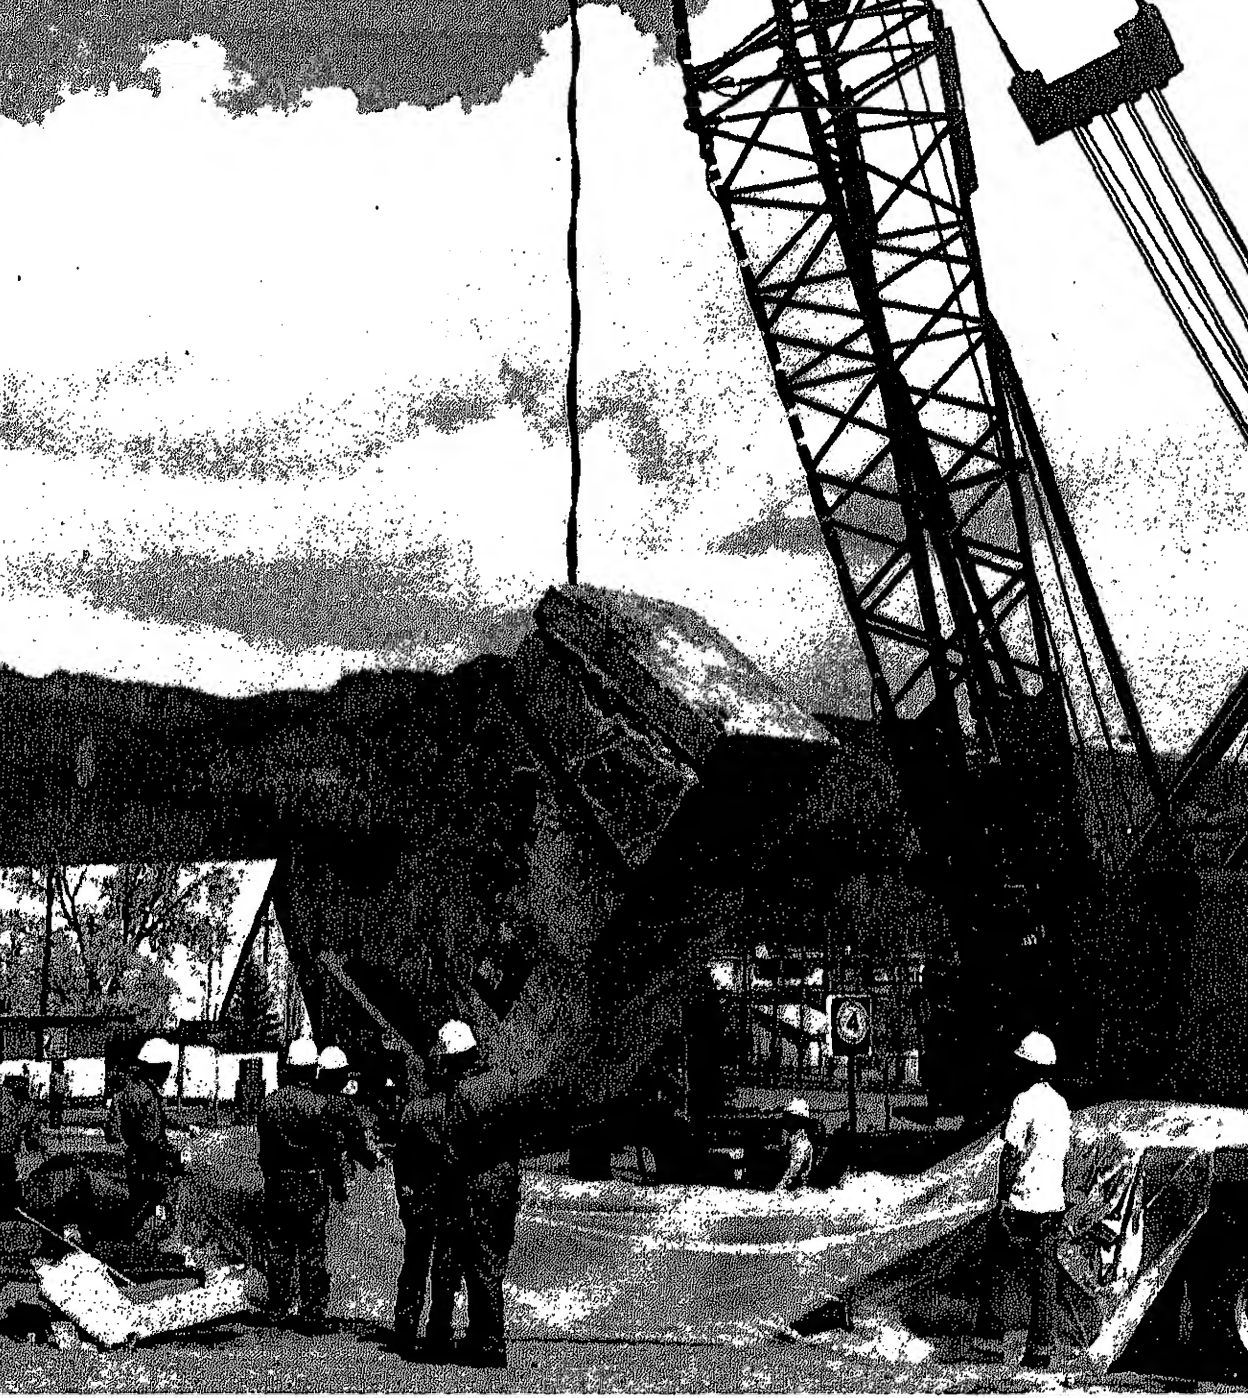
Fig. 23.
Manhole ULR-35 is loaded on a lowboy trailer.

this structure on this project (Figs. 20 and 21), contamination >100 000 counts/min on the phoswich and 5000 counts/min gross alpha on a survey meter were found in the soil on the northern and southern sides at the level of the inlet and outlet ports. The contamination originated from inadequately sealed ports (Fig. 22). A sample near the port that had 1400 pCi/g of gross-alpha activity on the ZnS system, was analyzed radiochemically and the isotopes identified were ^{238}Pu (20 ± 1 pCi/g), ^{239}Pu (760 ± 30 pCi/g), ^{241}Am (200 ± 4 pCi/g), ^{137}Cs (50 ± 3 pCi/g), ^{60}Co , and ^{235}U . Holes were drilled into the top of inlet and outlet pipes prior to cutting the pipes to determine if liquid was present. There was none. The manhole was removed and taken to the waste disposal area (Figs. 23 and 24) and the excavation decontaminated to as low as practicable.

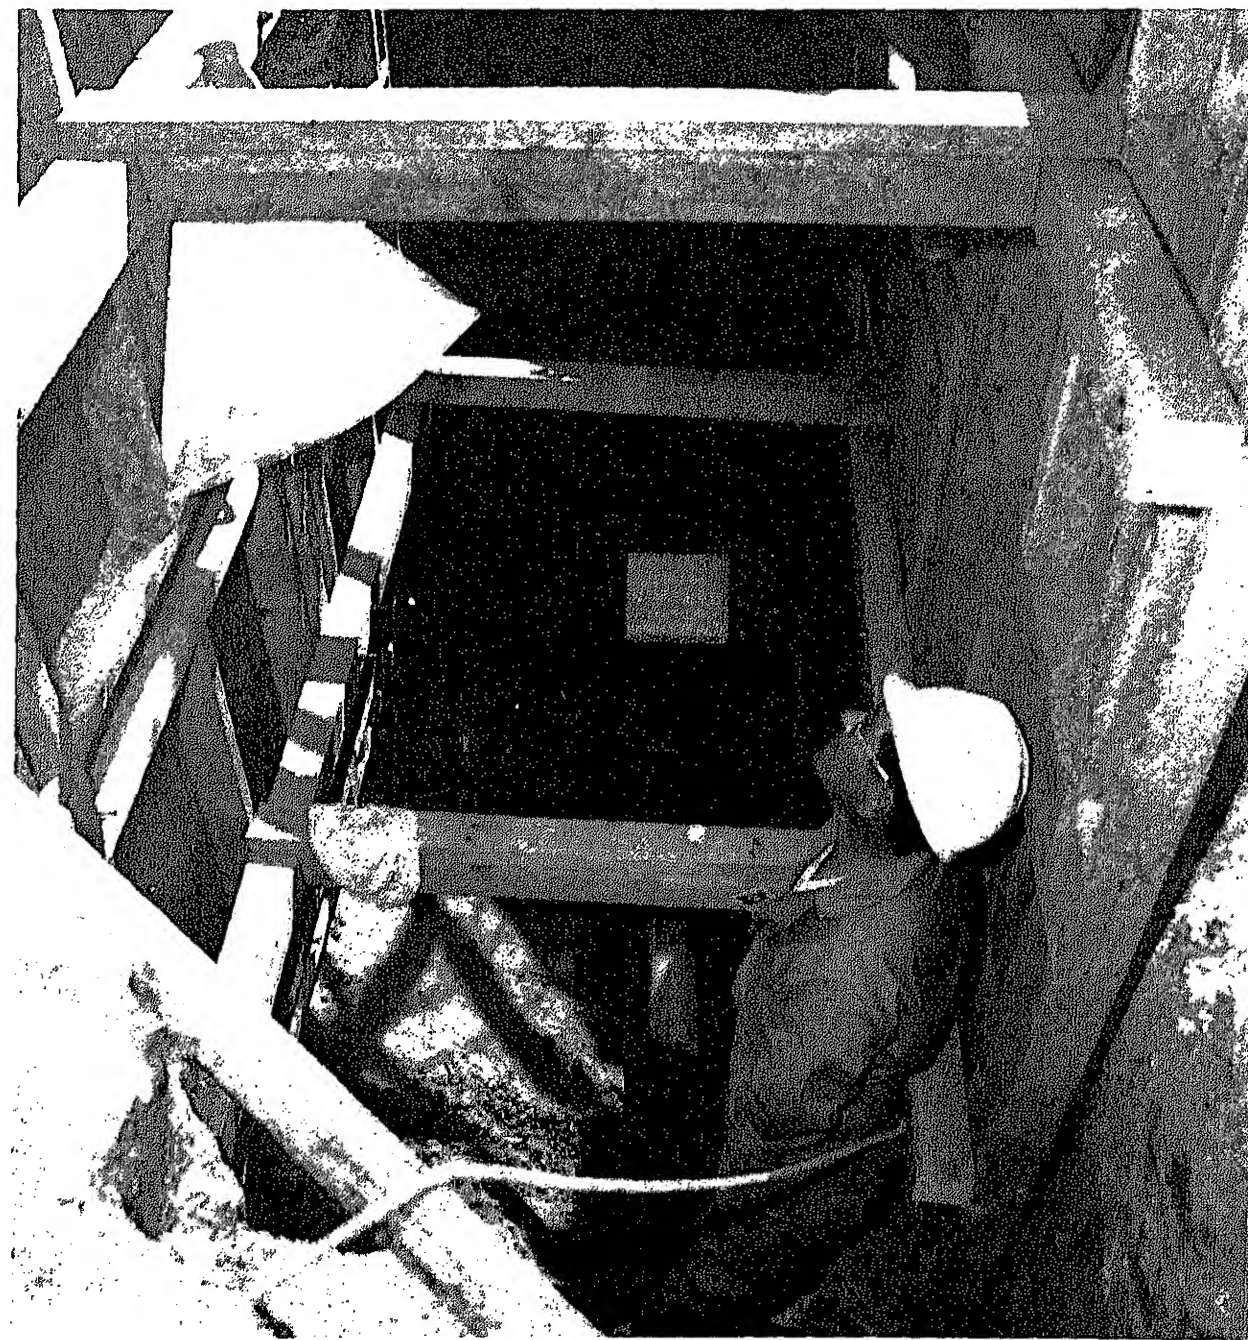
The outlet pipe exiting ULR-35 ran north through a 30-cm diam casing under Trinity Drive (Fig. 25). The pipe was found with a loose concrete seal over its end at 40+00. Some gross-alpha contamination (~ 1300 pCi/g) was found on the northern edge of the casing. Soil was removed until the area was decontaminated to ≤ 25 pCi/g of gross-alpha activity. The pipe running through the casing was removed and the casing cleaned out (Fig. 26). Dust problems during cleaning were eliminated by filtration of the casing air through a high efficiency particulate filter. A thin layer (< 5 mm thick) of rust too difficult to remove was left in the middle of the casing. A gross-alpha count of the rust was 300 pCi/60 cm². This condition was determined to be as low as practicable so the casing was grouted with concrete and left in place.

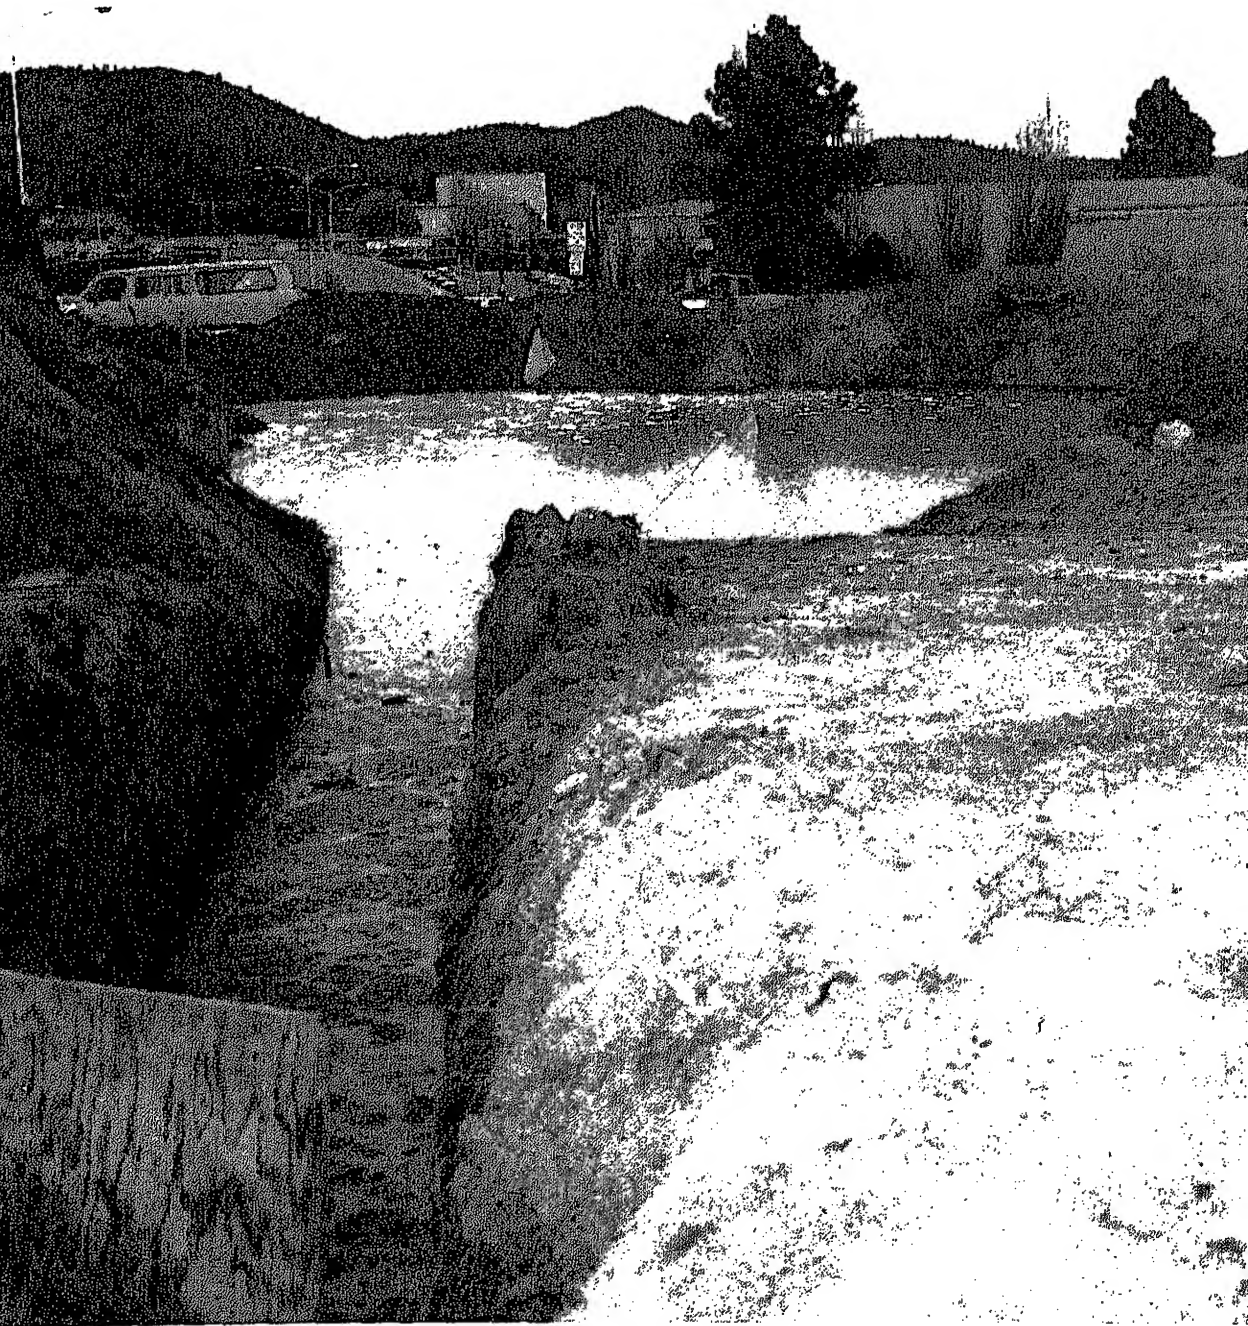
Fig. 27.

A domestic water line, between ULR-35 and ULR-60, located approximately 7 m above the clay pipe, was accidentally ruptured during this excavation. The water released was impounded (Fig. 27) and sampled for the presence of radioactivity. None was detected. The uncontaminated water was then pumped into nearby Los Alamos Canyon. After the water was removed, mud samples were collected and the absence of gross-alpha activity was confirmed. The trench was backfilled with pulverized tuff to absorb moisture. This material was then reexcavated and sent to the disposal area to permit resampling of the trench. No gross-alpha activity was detected at any time.

A domestic water line, between manhole III R-35 and III R-60, is accidentally ruptured dur

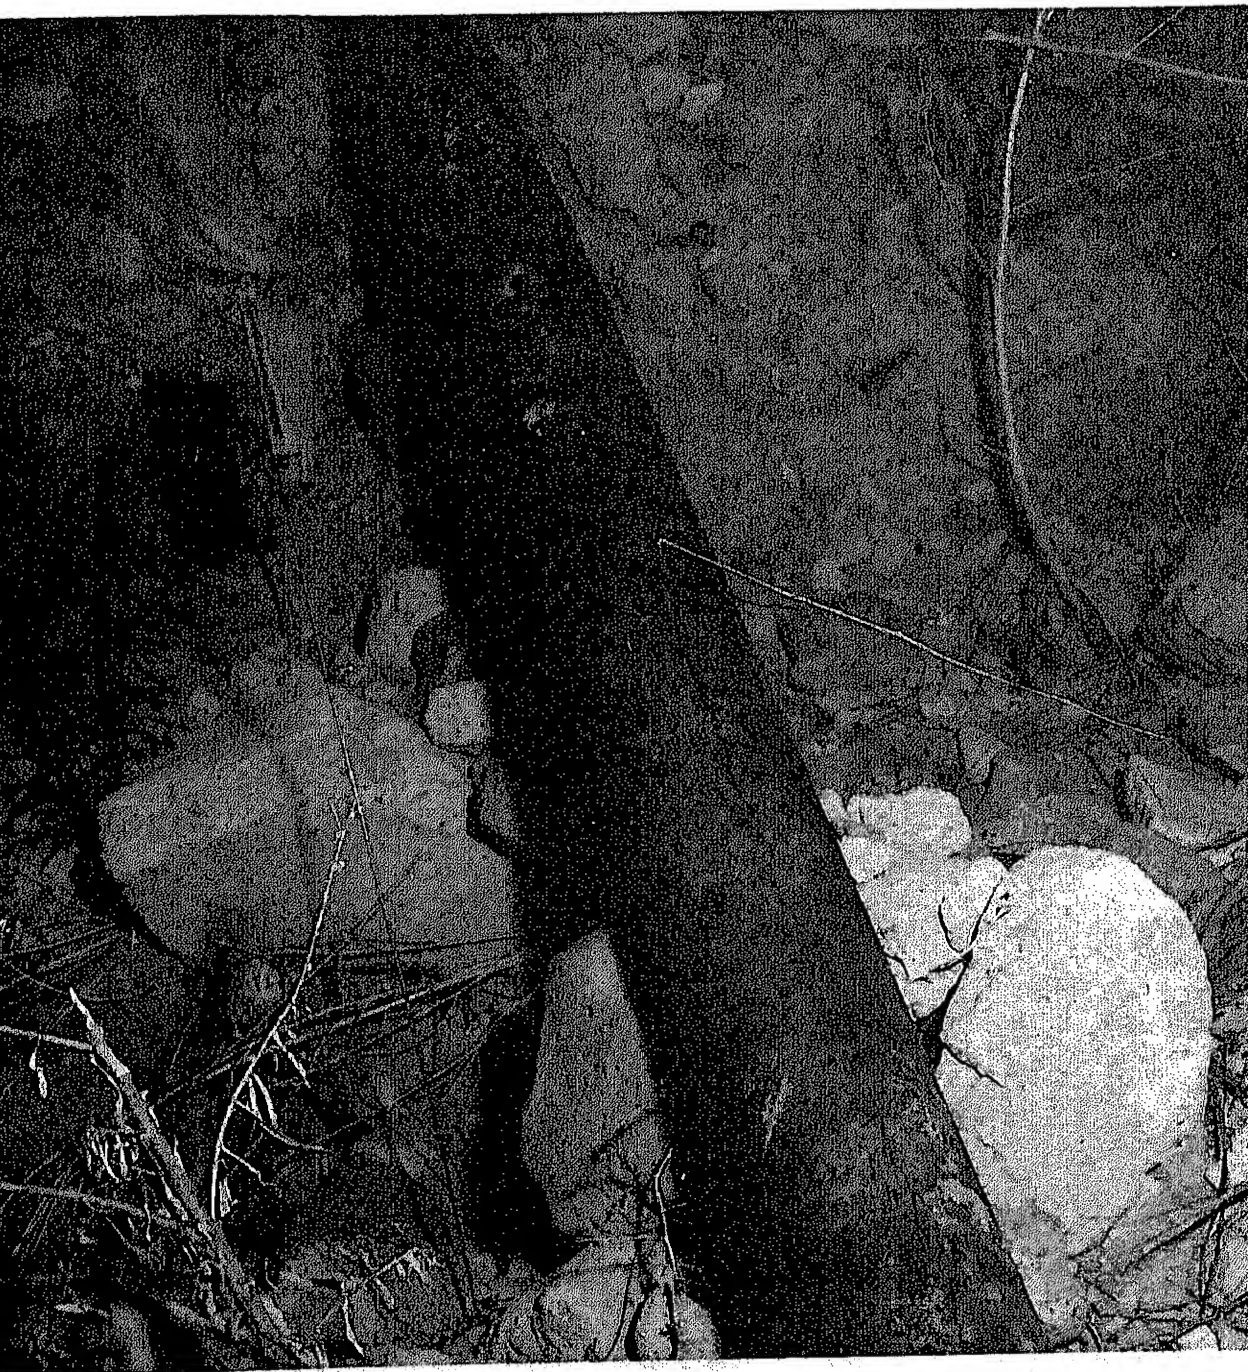
Fig. 29.

contamination of 49 pCi/g was found under one crack; the area was decontaminated to ≤ 25 pCi/g.

Crack in exposed cast iron IWL under Los Alamos Canyon bridge (27+19 to 27+74).
